RE: PORT OF PASCO, OLD GRAIN TERMINAL PIER

This is the report on the Old Grain Terminal Pier located on West River Street. The pier structure is an approximately 240 feet long, single story, wood frame structure supported on wood piles. Approximately 95% of the pier structure is over the waters of the Columbia River.

Meier Architecture • Engineering (Meier) conducted a site observation of the facility on April 30, 2012. The observations were visual only, and no material testing or other inspections were done. The observation was for general layout and construction of the structure, so not every structural member was observed. Certain measurements were taken to determine general structural layout.

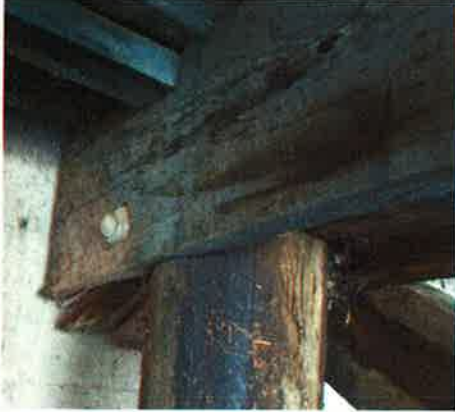
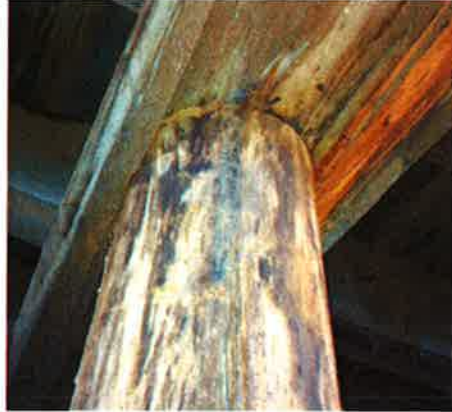
We observed approximately 8 bays where there appears to be extensive crushing of the girders on the wood piles.

This crushing was observed on the first four piles on the north end of the pier near the loading dock between bays 4 to 11, with bay one occurring on the west end of the pier.

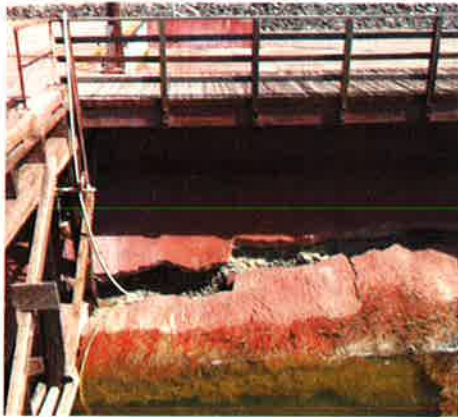
There were also a few sections of the shotcrete retaining wall that has spalled off and are bearing against the 11" diameter posts.

Based on our visual observations, the Old Grain Terminal Pier does not have adequate load carrying capacity to support a car or truck loading, but is still adequate for pedestrian loading. However, the walkway to the east of the main pier is not recommended for any use. The east pier has limited access due to not allowing access to the walkway and the height of the structure above grade. It is recommended that stairs are provided to access the east pier. In addition, it is also recommended that the pieces of spalled shotcrete wall that are bearing on the posts be removed.

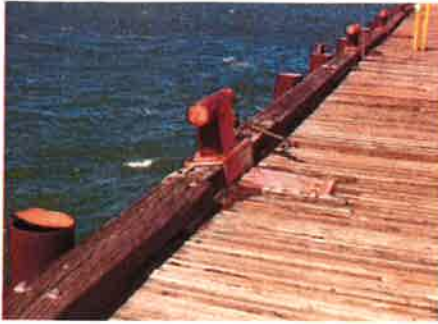
The existing bollards/mooring posts are damaged in places and it is recommended that barges not tie off until they can be reinforced back to the wood structure. Refer to attached sketch SKS-01 for recommended bollard/mooring post fix.
